AUX-USB Plug Saver

Part #: AGA-A-U-PS

AUX-USB Plug Saver Instructions

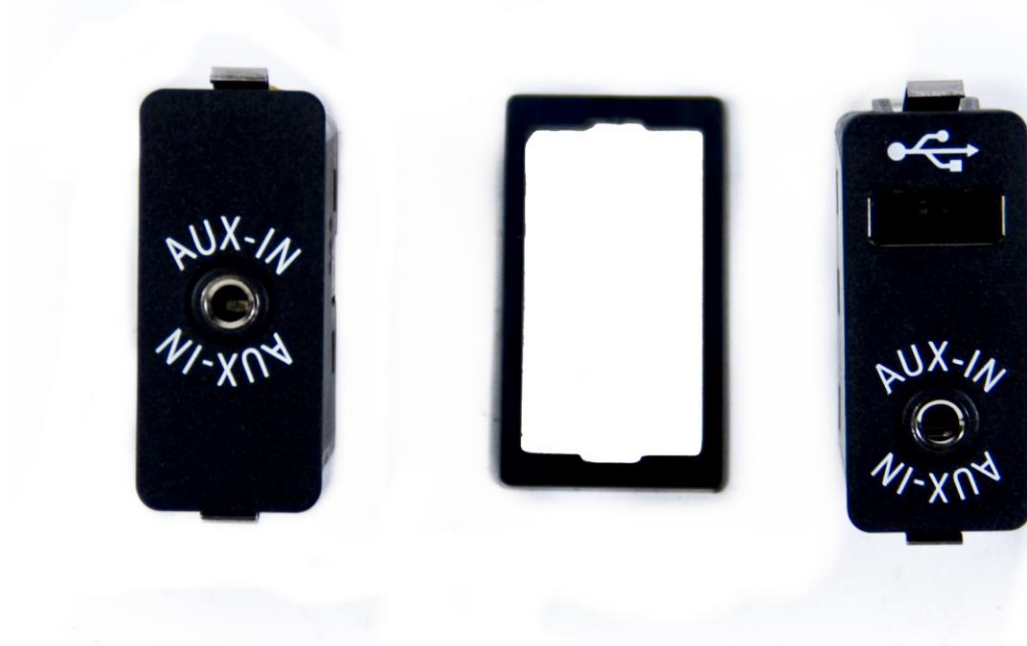
BMW E90 chassis, or any chassis with the same AUX-USB plug, has a broken aux connector in center counsel. This causes the USB and AUX connector to drop into the center console, making it impossible to plug in to the connector.

AGA's AUX-USB Plug Saver is manufactured from spring steel, heat treated and black oxide to match the interior color of the center console and AUX-USB switch.

The AUX-USB Plug Saver helps save time and money by providing an alternative to replacing the center console.

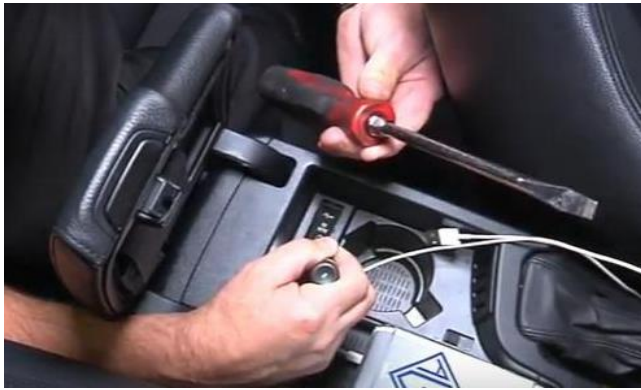
Step 1:

Start by fishing the AUX connector out of the hole it has fallen into. Align with a pick on the inside and use a screw driver from down below.

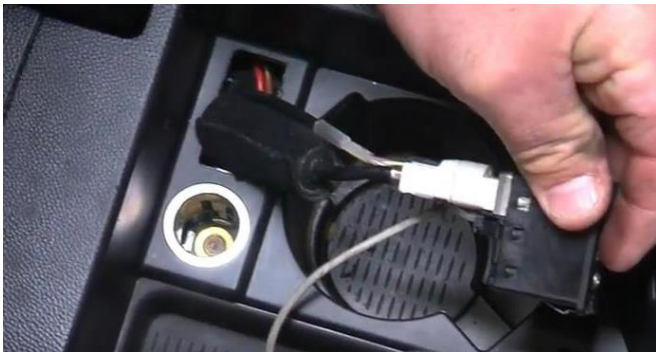
Step 2:

Once the connector is out, make sure the wires don't fall back into the hole. Carefully push on the plastic tabs and disconnect the two connectors to the AUX-USB power.

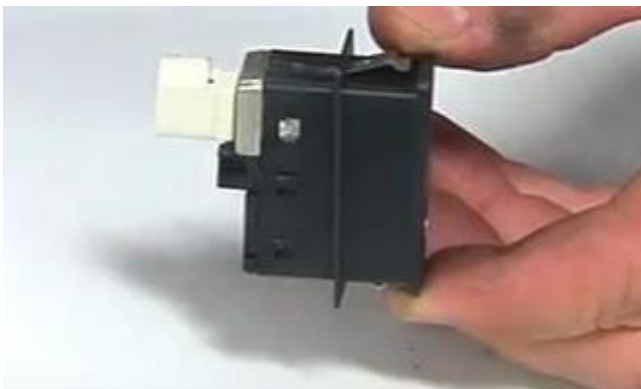
Step 3:

To install the AUX-USB Plug Saver, slide it over the housing of the connector, until it clicks into place.

NOTE: Push metal frame over the metal tabs at the same time to avoid bending the USB-AUX Plug Saver.

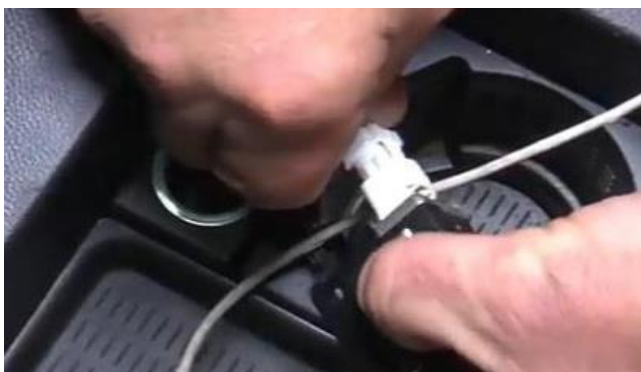
Step 4:

Connect the USB power then connect the AUX connector back to the back of the switch. Push the wires in and push the switch back down.

NOTE: If area where metal tabs make contact is damaged, it may be necessary to clean up center console with exacto knife or similar. Carefully bending the metal tabs outward on USB-AUX Connector to increase tension may also be needed.
